GHGT-12

## Characterization of CO<sub>2</sub> Pipeline Material from the Ketzin Pilot Site

### Abstract

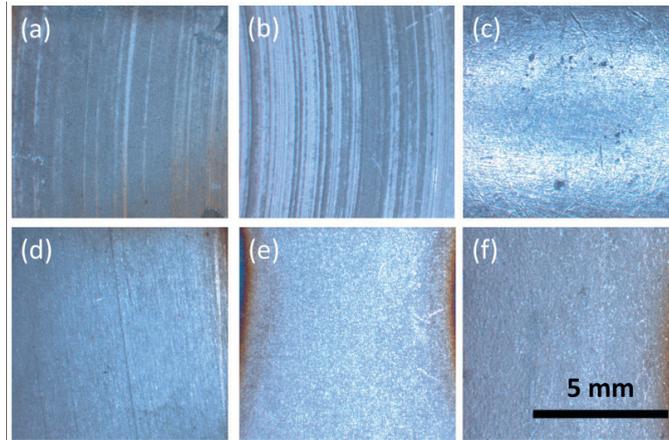
By visual inspection of pipe edges after cutting, it was observed that neither erosion nor corrosion penetrates deep into the bulk stainless steel. Figure 2 shows optical microscope images of inner surfaces of all four samples and outer surface of sample 2. It is apparent that the pipes have different appearance of inner and outer surfaces. The outer surface (Fig. 2c) has more scratches and is metallic grey in colour. All inner surfaces have a slightly different colour. Otherwise, no visual signs of corrosion were observed. The bent section of sample 1 (Fig. 2a,b) exhibited a different colour on the inside (brownish to dark grey) compared to the other samples (grey). This can be due to welding or pipe bending prior to  $\text{CO}_2$  flow. In addition, the inner surface of sample 1 at the bent section appeared to have distinct dark lines along the flow direction. On the inner surface of sample 2 (Fig. 2d) some similar weak lines can also be observed. This is in contrast to samples 3 and 4 (Fig. 2e,f), which both seem to have a homogeneous roughness.

Fig. 2. Optical images of the pipes after cutting: (a) Sample 1 sharp section, inner surface, (b) sample 1 top section, inner surface, (c) sample 2 blunt section, outer surface, (d) sample 2 sharp section, inner surface, (e) sample 3 top section, inner surface, (f) sample 4 top section, inner surface.

Little corrosion was visible on the pipe surfaces by optical inspection (Fig. 2), and the pipeline can thereby be said to have withstood the environment to which it had been exposed during the five years of CO<sub>2</sub> injection. Various SEM techniques and a profilometer were used to map the surface structure at micro-scale, chemistry and roughness of the pipe sections. This revealed some signs of corrosion over the whole inner surface for all samples, especially in

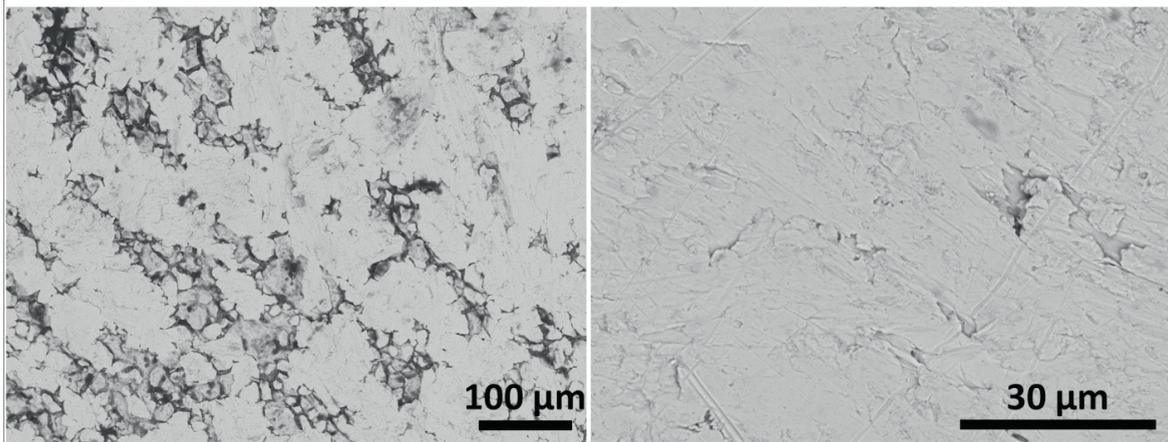
Despite little corrosion being visible by optical inspection, at higher magnification, SEM revealed that the pipe surfaces had in fact been affected by the prolonged CO<sub>2</sub> flow. No new pipeline material, unexposed to outer conditions or CO<sub>2</sub>, was available for comparison. So for a reference, outer surfaces of samples 2 and 4 were studied by SEM. During injection, this surface had been exposed to the outer conditions instead of CO<sub>2</sub>. As seen from Fig. 3 on the left, the outer surface of the sample 2 (similar for sample 4) has a high density of seemingly deep, large pits (up to few hundreds of μm long) in between rather smooth regions. But there are traces of intergranular corrosion in these smooth regions as well. This is indicated by the tiny cracks in between the steel grains where loss of material occurred and/or corrosion products precipitated (darker regions), Fig. 3 on the right. Otherwise, we assume that this is how the inner pipe surface used to appear before the CO<sub>2</sub> injection started.

Fig. 3. BSE images at two different magnifications of the outer surface, that has not been in contact with CO<sub>2</sub>, of the blunt sample 2.

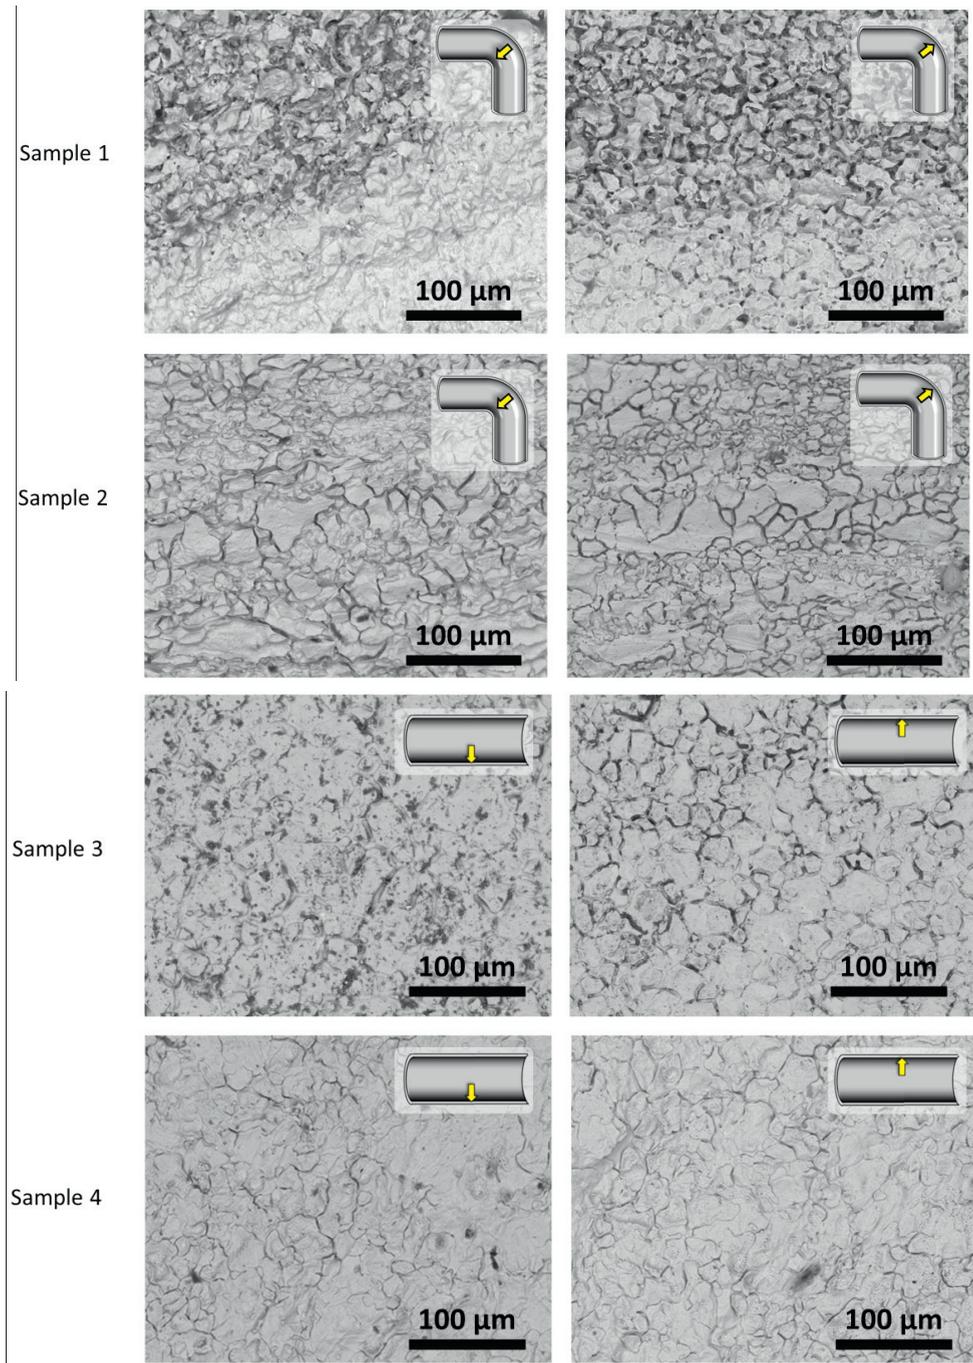
Several regions of the inner surface of the CO<sub>2</sub> transport pipeline were also analyzed by SEM, and the results are summarized in Fig. 4. For samples 1 and 2, the sharp and blunt bent sections are compared, while for samples 3 and 4 the top and bottom sections of straight pipe sections are compared. The location in the pipe is indicated in the top right corner of each figure. As seen from this overview figure, all samples display a cracked surface layer, which is typically the first sign of onset of corrosion. Intergranular corrosion, with loss of material in between grains, is also visible in all the samples. Overall, sample 1 has the most corroded inner surface – followed by sample 2. The grooves in the cracked surface layer appear to be shallowest in sample 4.

There are little differences in corrosive attack between the sharp and blunt sections of the bend in samples 1 and 2. For sample 1, the sharp section had a higher density of dark/brownish lines than the blunt one (also visible by eyes/in optical microscope, Fig.2), but the degree of corrosion was similar. In Fig. 4, a transition between a dark line and lighter region in between the lines is shown from sample 1. Corrosion degree of both sharp and blunt sections of sample 2 appears similar to samples 3 and 4, except that the grooves seem to be deeper. Further, as Fig. 4 displays, there was little or no difference in corrosion between the top and bottom sections of the straight pipes (samples 3 and 4) which were overall less attacked by corrosion than the blunt and sharp sections of samples 1 and 2.

Fig. 4. BSE images of the inner surfaces of all the samples described in Table 1. For the bent pipe samples the sharp and blunt section of the bend is compared, while for the straight pipe samples the top and bottom section of the pipe is compared.

The sample collected close to the inlet of the ambient air heater (Sample 1) was the most corroded one (Fig. 4). This sample was exposed to liquid  $\text{CO}_2$  and subject to lowest temperatures (about  $-15^\circ\text{C}$ ) and most constant temperature conditions during operation. Sample 2 which was also exposed to liquid  $\text{CO}_2$  but ambient temperature and its natural fluctuations, was the second most corroded sample. Samples 3 and 4, where gaseous  $\text{CO}_2$  with higher temperatures (about 30 to  $45^\circ\text{C}$ ) had flowed during standard operation, exhibited lower degree of corrosion. Physically, this could be based in a higher activity of residual water and formation of carbonic acid. Higher temperatures in contrast correlate with lower corrosion, which supports the former hypothesis.

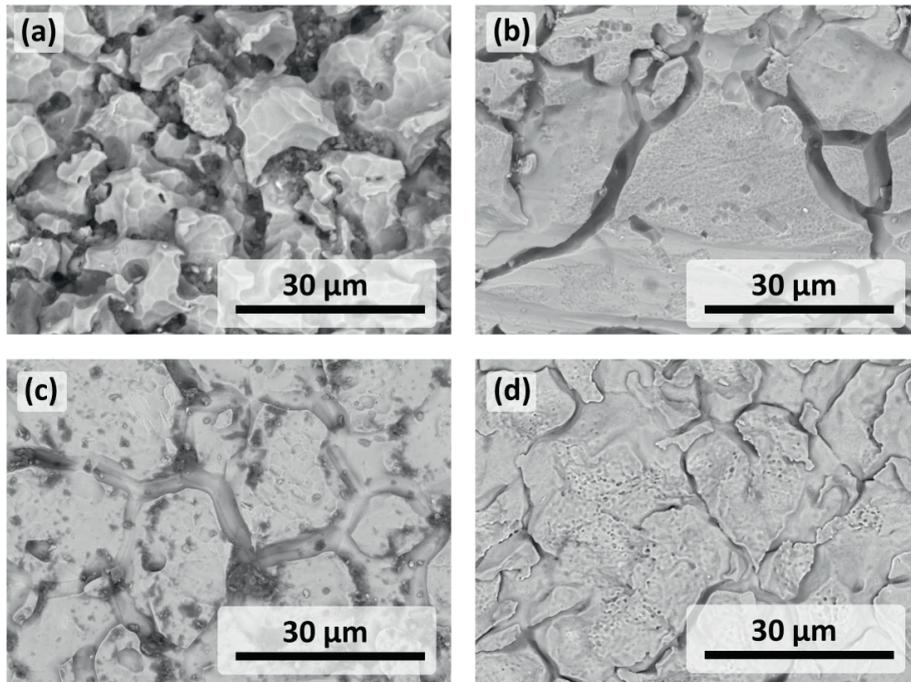
Higher magnification BSE images in Figure 5 show different types and degrees of corrosion observed in the four samples. This figure depicts especially corroded areas. Sample 1 is dominated by strong intergranular corrosion, while for sample 2, deep grooves of intergranular corrosion are visible. Sample 3 displays signs of intergranular corrosion as well, but the grooves are not especially deep. For sample 4, some shallow intergranular corrosion was observed. Not all grains were separated in samples 3 and 4 – so what we observe is most likely only the onset of intergranular corrosion. The micro-sized holes or craters on grain surfaces (not at their boundaries) confirm that there is also some pitting corrosion on most of the surfaces. Some large pitting craters are visible for sample 1 (Fig. 5a), and some smaller and more shallow ones for samples 2, 3 and 4 (Figs. 5b,c,d). The particles (dark) in between or on top of the grains, as seen in Fig.5(a,c) may be corrosion products or contamination or both.

Fig. 5. High magnification SEM images of the most corroded regions of the inner surface for each of the samples. (a) Sample 1, (b) Sample 2, (c) Sample 3 and (d) Sample 4.

Intergranular corrosion was the dominant form of corrosion, but some pitting corrosion was also observed (Fig. 5). The intergranular regions were either voids or including particles containing carbon and oxygen (Fig. 6). Auger spectroscopy indicated that the protective chromium oxide layer was severely damaged (Fig. 7). As seen in Figs. 5 and 7, some grains are more severely attacked by pitting corrosion than others. This is likely to be coupled to the grain orientation, as some crystal orientations are more susceptible to corrosion than others [17].

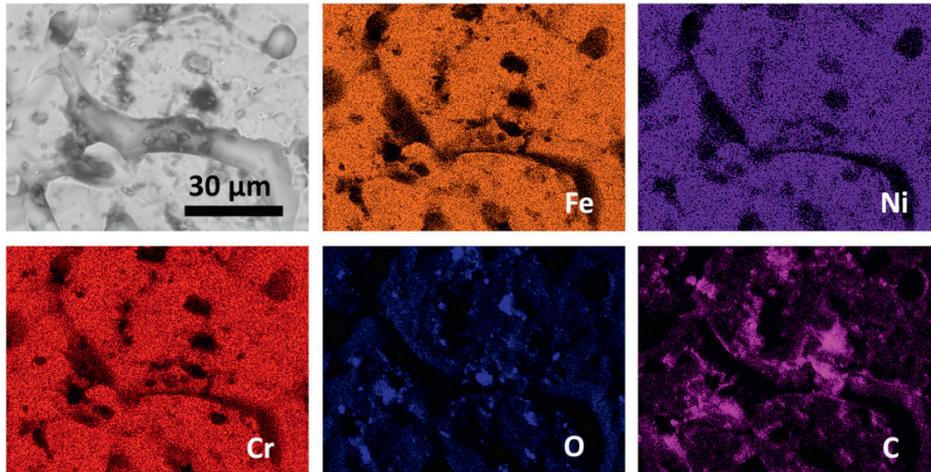
The surface composition of the different samples was studied by two analytical techniques, EDX and Auger spectroscopy. Both techniques confirmed the elements present in the stainless steel grade used in the pipeline, and revealed that all samples contained some carbon on the surface. Figure 6 depicts typical EDX maps from the pipeline with the most abundant elements in addition to carbon and oxygen. The latter two were included as they were the main constituents of the corrosion products or possible contamination or protective oxide layer on the surface. The main elements (Fe, Ni, Cr) are present overall, i.e. their EDX maps are matching well the corresponding BSE image in Fig.6. However, overall weak O signal (with specific spots of higher counts) indicates depletion of the protective chromium oxide layer, which is characteristic for ongoing surface corrosion. The carbon could originate from contamination or corrosion products or both. Note that it is impossible to determine the exact composition of possible corrosion products by using only EDX in SEM.

Fig. 6. BSE image and EDX mapping of the inner surface of sample 3. The main elements in the stainless steel are included in the mapping. Oxygen and carbon are shown as well, as these were prominent in the oxide layer and corrosion products/contamination.

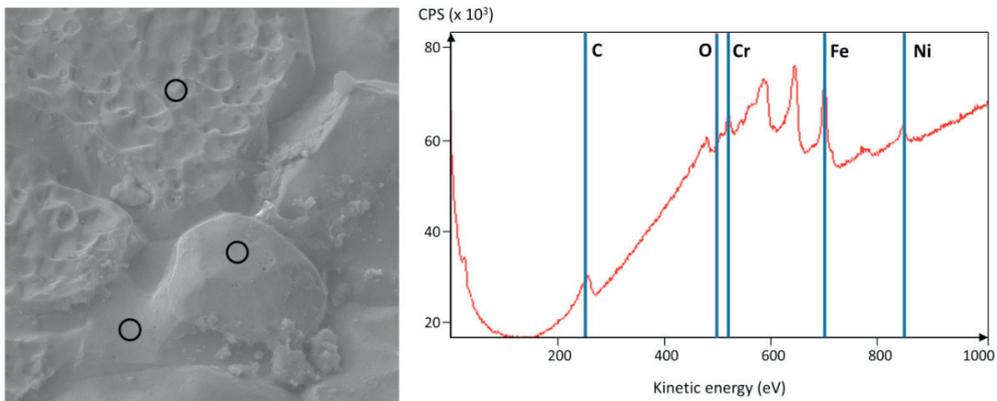
The surface composition of sample 3 was analyzed using Auger spectroscopy, and the results are depicted in Fig. 7. Initially, strong C peak and weaker O peaks were dominating the Auger spectrum (Fe, Cr and Ni not detected), indicating carbon contamination at the surface. After 8 minutes of sputtering to clean the sample, C peak was drastically reduced. Fe, Ni and Cr peaks then emerged, but Cr and O peaks were rather weak compared to Fe and Ni. The opposite would be expected if chromium oxide layer was preserved on the surface. The weak Cr and O peaks at the surface indicate that the protective chromium oxide layer has been damaged or even completely eroded. This is in line with the EDX results.

Fig. 7. SEM image of sample 3 indicating points on the surface analyzed by Auger spectroscopy. All points gave spectra similar to that depicted on the right, where the main peaks of the elements are marked with blue lines. Secondary (lower energy) peaks of Fe, Cr and Ni are not denoted.

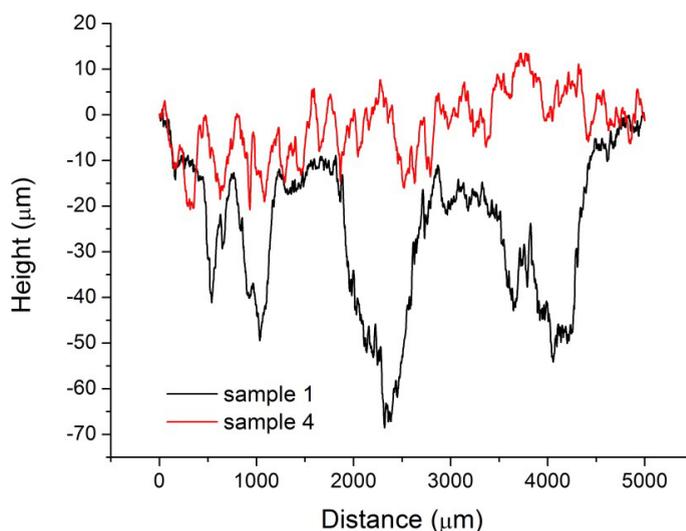
A typical surface height profile, represented by sample 4, and surface profile across the dark/light lines for sample 1 are shown in Figure 8. Here sample 4 represents the case where roughness is independent of CO<sub>2</sub> flow direction (samples 2, 3, 4). The average peak-to-valley distance was about 20  $\mu\text{m}$ , which is an estimate of corrosion depth.

Sample 1 had a similar height profile to sample 4 when scanned along dark lines or in between them, as seen in Fig. 2(a,b). However, when scanned across the lines, the profile changes drastically, as seen by the black plot in Fig. 8. Drop in height (valleys) correspond to the dark lines, while peaks to the light regions in between. This means that the dark lines as seen by eye/optical microscope are actually furrows. This is also reflected in roughness values: about 14  $\mu\text{m}$  across the furrows, and 2.2 – 4.7  $\mu\text{m}$  along. The peak-to-valley distance in this case is about 70  $\mu\text{m}$ , as seen in Fig.8, significantly larger than in sample 4.

Fig. 8. Surface height profiles of samples 1, across the lines as seen in Fig.2(a,b), and sample 4.

The deep furrows (up to 70  $\mu\text{m}$ ) at the bent section of sample 1 are unlikely to be caused by the flow pattern of the  $\text{CO}_2$  mixture through so-called erosion corrosion [16], since the furrows exist evenly distributed on the inner surface of the bent section and not at all in the straight sections. These furrows may have originated from the initial pipe processing, and subsequently corroded due to  $\text{CO}_2$  flow. In addition, it would not be expected to observe a high degree of erosion with a fluid composition with just a small amount of (or no) solid particles. A possible explanation for the increased corrosion on the sharp section of the bend in sample 1 is that the process is dependent on adsorption of molecules to the surface, a process which again could be dependent on the fluid velocity or phase (liquid vs gaseous).
